Technical Note
OSP/LV-77-2

**RADIOLOGICAL SURVEY AT THE
INACTIVE URANIUM MILL SITE
NEAR RIVERTON, WYOMING**

JUNE 1977

**U.S. ENVIRONMENTAL PROTECTION AGENCY
OFFICE OF RADIATION PROGRAMS
LAS VEGAS FACILITY
LAS VEGAS, NEVADA 89114**

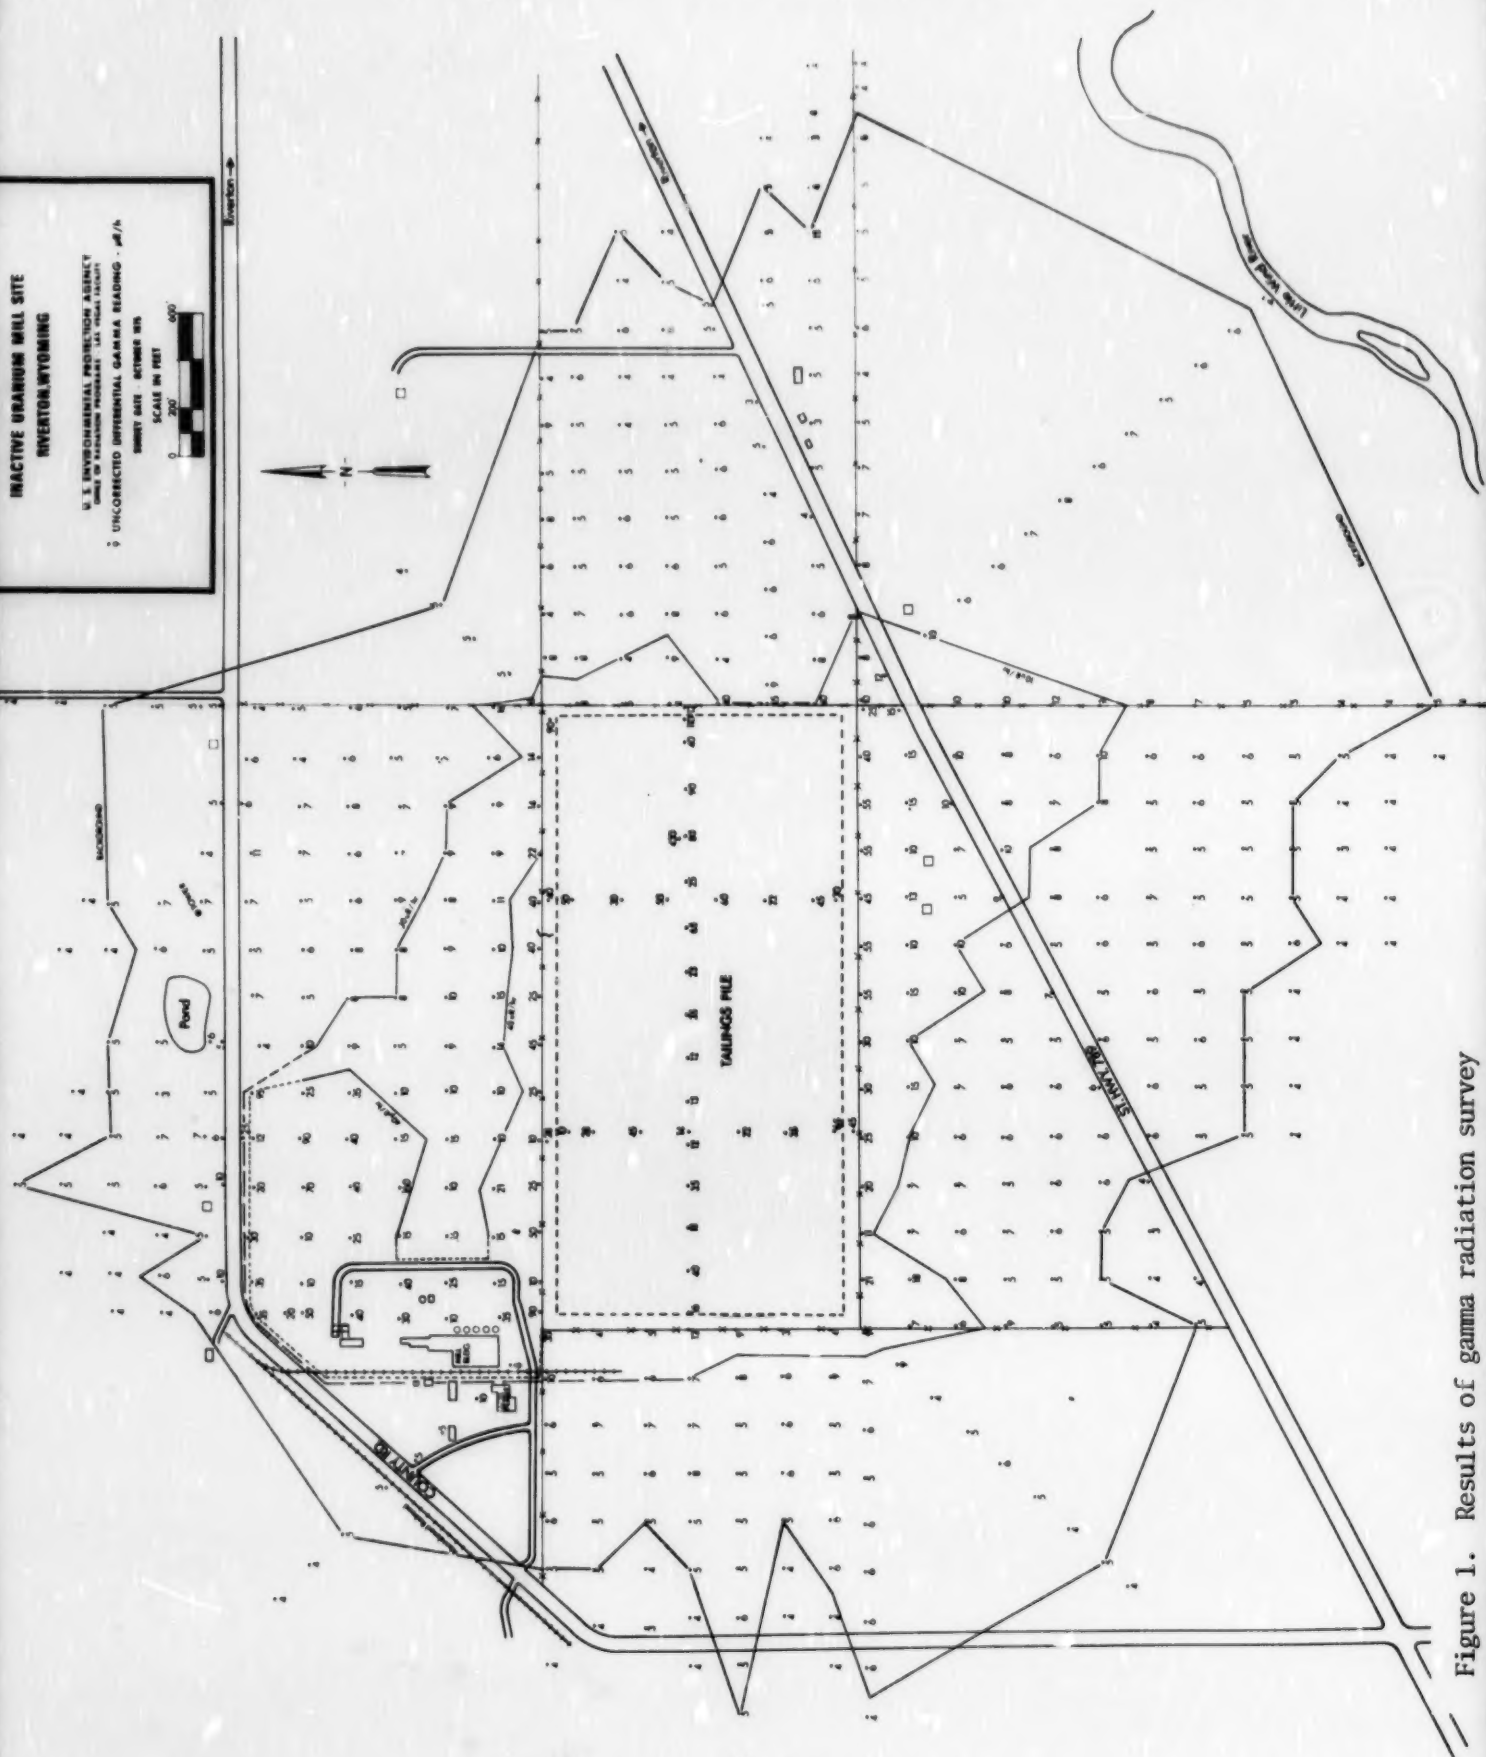
Figure 1. Results of gamma radiation survey

The results of the gamma survey are shown in Figure 1. The delta value is shown at each measurement point. Iso-exposure rate lines were constructed on the basis of these delta values by the method of Douglas and Hans (1975). In keeping with current Environmental Protection Agency guidance (EPA, 1974) iso-lines corresponding to residual gamma exposure rates of 40 μ R/hr, 10 μ R/hr, and background were located. The significance of these lines is as follows (Douglas and Hans, 1975):

As can be seen in Figure 1, the most extensive area of contamination lies in a sector southeast of the pile. The maximum distance from the pile fence to the background line was about 2500 feet east of the southeast corner of the pile. The land in this sector is mostly undisturbed range land. The land immediately east and northeast of the pile is cultivated. This cultivation quite likely has reduced the level of surface contamination (as measured by the delta method) by mixing windblown tailings material into the soil. Therefore, more tailings have probably been deposited on the east and northeast sectors than the results of this survey indicate.

In view of these results, the location of the 10 μ R/hr line in the field east of the pile, and of both the 10 μ R/hr and background lines in the field northeast of pile, should be considered only approximate, since they only represent current levels of surface contamination.

The 40 μ R/hr line encompasses an area of about 30 acres, exclusive of the tailings pile. This includes a strip averaging about 200 feet in width along most of the north side of the pile, and former ore storage area northeast of the mill yard. The mill yard itself was arbitrarily included within the 40 μ R/hr line, as indicated by the dashed line. The delta readings in the mill yard were too erratic to allow construction of the 40 μ R/hr line, due to the spotty nature of contamination in the yard. However, it is apparent that the entire mill yard is sufficiently contaminated to warrant decontamination.

The 10 μ R/hr line encompasses about 99 acres, exclusive of the tailings pile. As discussed above, the mill yard was included within this line. The dashed portion of this line along the west side of the mill yard and along the county road north of the mill indicate that the delta readings were not sufficiently uniform in these areas to allow the theoretical construction of the line. Therefore, the location of this portion of the line is somewhat subjective, and is based on adjacent readings and practical considerations for decontamination. Two houses south of the pile are within the 10 μ R/hr line.

The background line encompasses about 460 acres, exclusive of the tailings pile. Except for the two cultivated fields discussed above, this is largely range or pasture land. About six houses are within the background line.

The contaminated areas were delineated by making a series of differential gamma exposure rate measurements at the ground surface. A total of about 460 acres, exclusive of the tailings pile, was found to be contaminated above background levels. An area of 30 acres would have to be decontaminated to reduce the maximum residual exposure rate to 40 $\mu\text{R/hr}$, and 99 acres would have to be decontaminated to reduce the maximum residual exposure rate to 10 $\mu\text{R/hr}$.

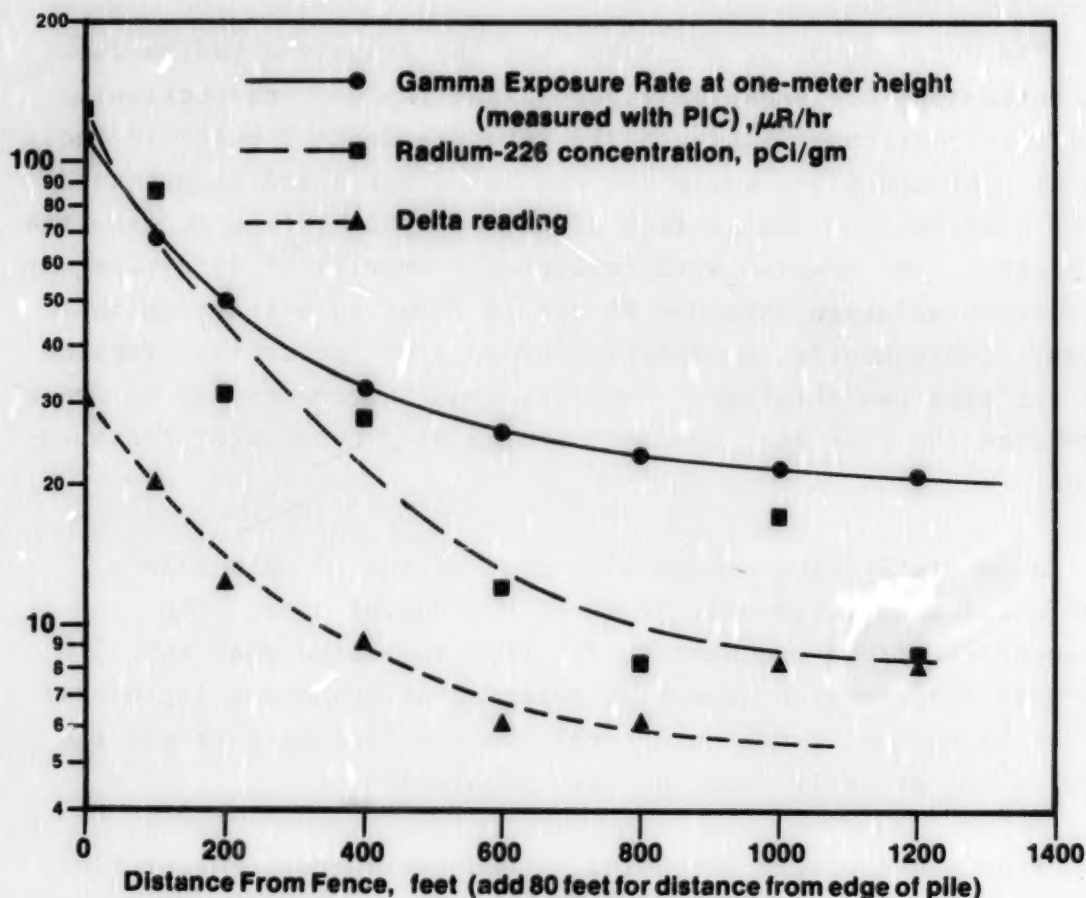
Figure 2. Radiological parameters as a function of distance from the tailings pile

The results of the special measurements to correlate gamma exposure rate, delta readings, and radium-226 concentration in the soil are shown in Table 2. Figure 2 shows the one-meter gamma exposure rate (PIC), delta readings, and radium-226 concentrations as a function of distance from the pile. In a relatively undisturbed area, such as the one chosen for this test, these parameters are shown to correlate very well. An unexplained source of activity (probably ore spillage) was

detected by both the delta and the radium-in-soil measurements about 1000 feet from the pile. This contaminated area was not reflected, however, by the gamma exposure rate measurements. This may be because the small increase was less than the sensitivity of the PIC, or because the one-meter gamma measurements "average" over a larger area than do the surface measurements. Whatever the reason, the delta method is shown to be a sensitive indicator of soil contamination.

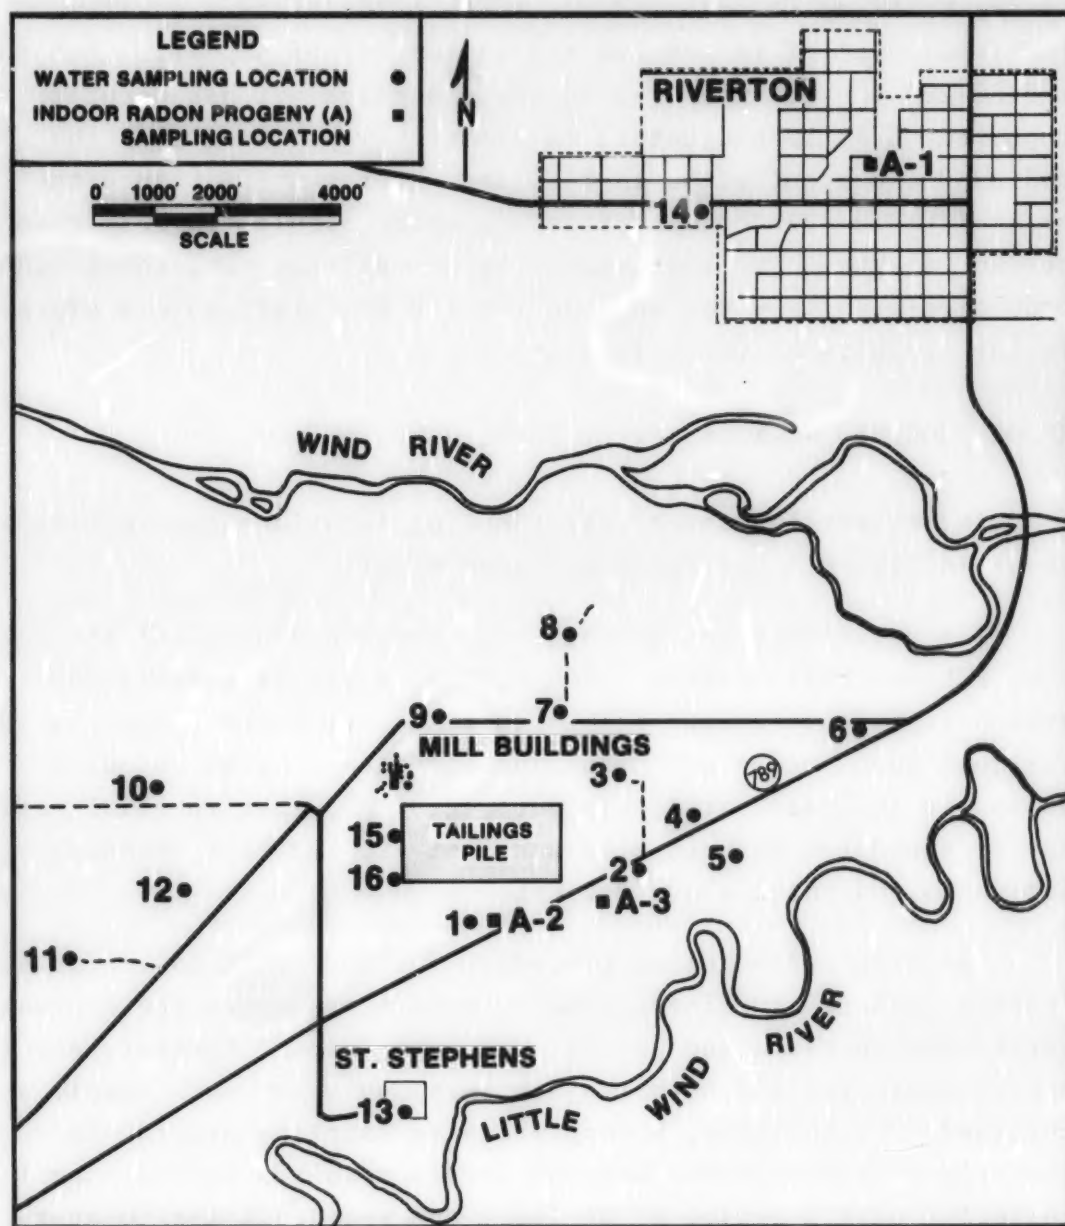
Figure 3. Location of water and radon progeny (working level) samples

The water sampling locations and the dissolved radium-226 concentrations are shown in Figure 3 and Table 3, respectively. Sampling locations #1 through #13 were residential wells in the vicinity of the pile, while #14 was in Riverton and is presumed to be a background sample free of any possible influence from the mill site. The samples were collected primarily to determine any potential radiation exposure to people drinking water from these wells. Consequently, no specific hydrologic information regarding the site was obtained. However, some inferences may be drawn regarding the pile as a possible source of ground-water contamination.

Another basis for evaluating the water sample results is by comparing them to current standards. The Environmental Protection Agency Drinking Water Standards (EPA, 1976) allow a maximum combined level of radium-226 and radium-228 of 5 pCi/l. Although radium-228 was not measured in these samples, it has been reported (EPA, 1976) that it is almost always lower than the radium-226 concentration in the same water sample. Since the maximum radium-226 concentration in these samples is less than 20 percent of the 5 pCi/l standard, it is unlikely that total radium concentrations in water approaching the EPA standard are present in the vicinity of the mill site.

Indoor working level (WL) sampling locations and results are shown in Figure 3 and Table 4, respectively.

With these qualifications in mind, it does not appear that significantly elevated indoor working levels exist in the vicinity of the mill site.
